Tests and FEM Calculations for the Screw Coupling 1MN

Abstract The article describes mandatory requirements for screw couplings in the service release. Additionally, the test results for the coupling and their comparison with FEM calculations are presented.

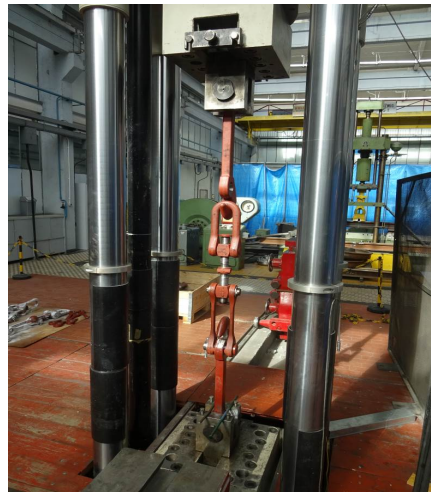
Fig. 1. Screw coupling 1MN on the testing machine during tests

Fatigue tests of screw coupling 1MN (part of the required tests) were carried out on a LFV testing machine with a maximum tensile force of 2.5 MN Fig.2. An example of a fragmentary graph of fatigue history is presented in Fig.3. The maximum tensile forces for the coupling were 575 kN during this study. The number of the highest loads $F = 575$ kN in the entire fatigue tests was 2150 cycles.

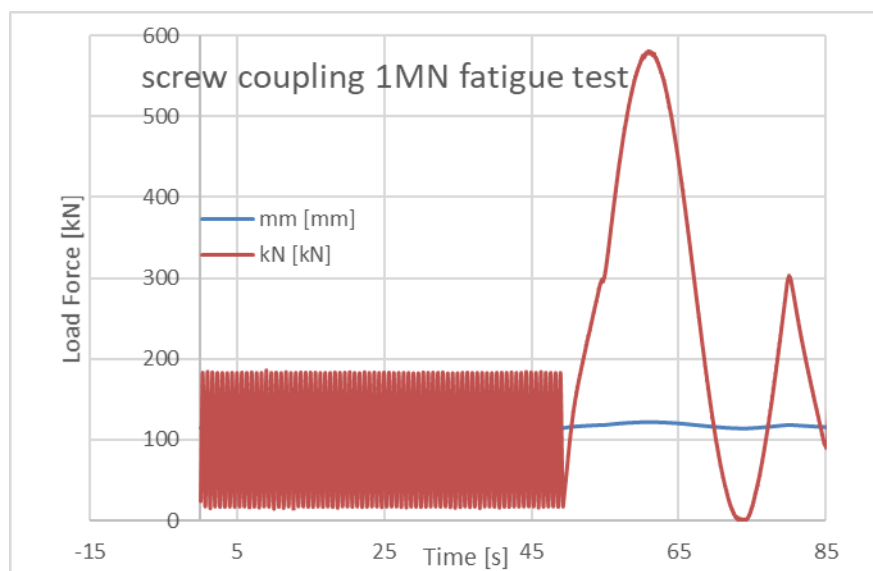
Fig. 2. The course of fatigue loads for the screw coupling

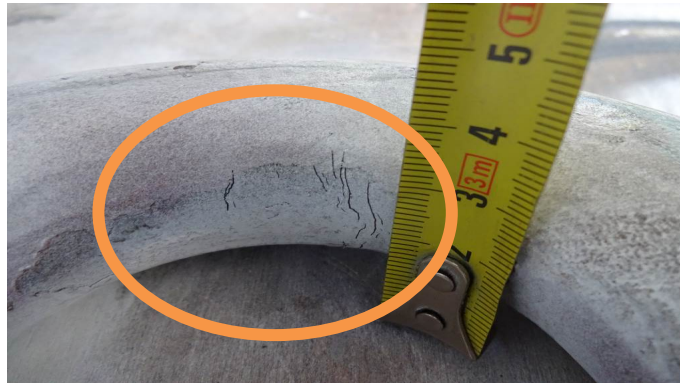
Fig. 3 Non-destructive testing NDT - magnetic-powder method, observations of the shackle screw coupling IMN after fatigue tests. Visible cracks in the marked area.

After the completion of fatigue tests, the screw coupling was subjected to destructive tests, using a magnetic powder method to assess the surface condition of the bow (screw coupling) in the area of surface contact with the hook. The NDT tests revealed cracks on the shackle of the 1MN screw coupling. The results of the tests (Fig.4) are presented below. Regarding the requirements and assessment criteria described in standard EN 15566:2016, discontinuities / fractures up to 20 mm are allowed.

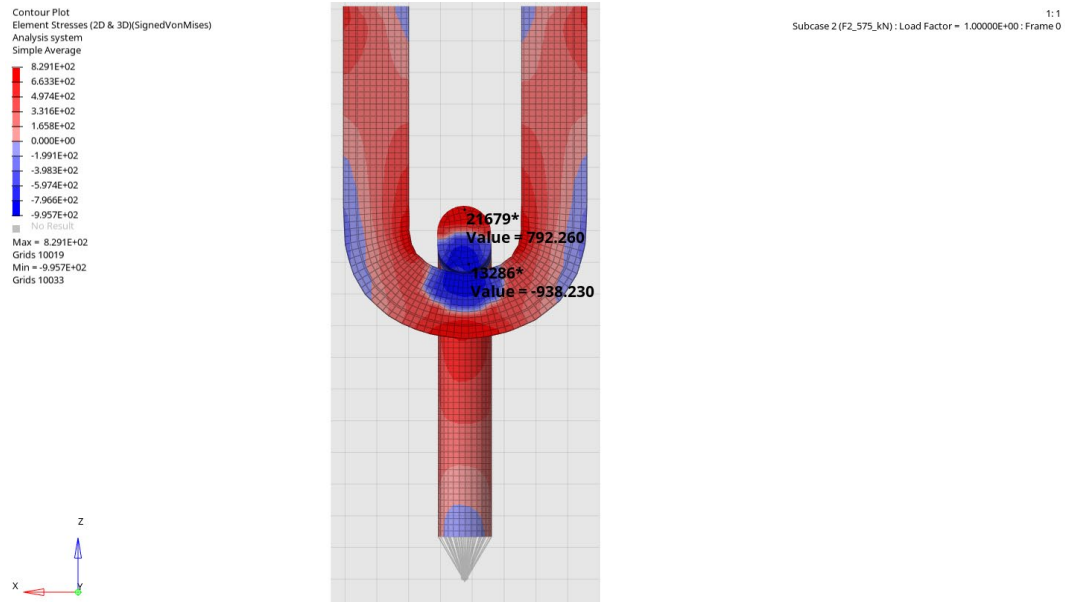
Fig. 7. Graphic representation of stress distribution in the shackle of screw coupling. Tensile and compressive stresses according to Signed/von Mises for a load of 575kN.

In the contact hook/shackle area, mainly compressive stresses (blue colour) occur, which is shown in Fig. 7.
