Microstructure and Mechanical Properties of Dissimilar Friction Welded B500B-1.4021 Steel Joint

Abstract. In this study, unalloyed reinforcing steel (B500B) is merged with martensitic stainless steel (1.4021). The paper presents microstructural observation, hardness measurements, and tensile test results of this dissimilar joint as-welded. In this specific case, no heat treatment is demanded. The joint is a part of the pile foundation for railway traction lines.

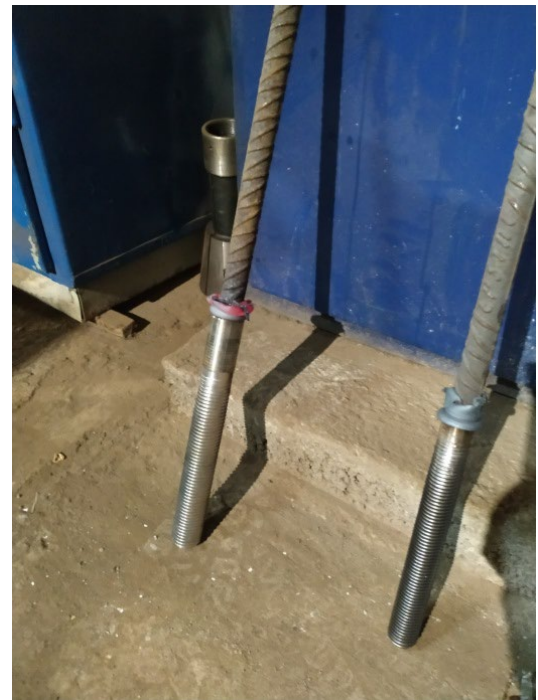
Fig. 1. The joint after welding

Materials and Welding Parameters. The manufacturer company prepared the joints (Fig.1) according to approved welding technology using the ZT3-22 machine. Each joint was made between a ribbed reinforcing steel bar and martensitic steel 1.4021/X20Cr13 (AISI 420) anchor. The chemical composition of base materials and technological conditions are presented in Tables 1, 2, and 3. The microstructure of the base materials is shown in Fig.2.

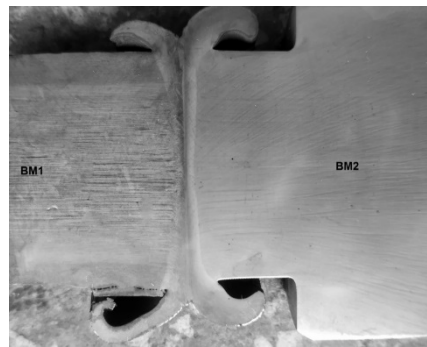
Fig. 4. Macrostructure of the joint with asymmetrical flashes

The microstructure of base material 2 – stainless steel consists of tempered martensite with carbide precipitations (Fig. 2 – right side). The weld line is very narrow, but the thermo-mechanically affected zone (TMAZ) is about 400 μm near the center and broader on the peripheries (Fig. 4). Next to the flash, many partially mixed regions can be observed. In the core, there are many deformation lines and bands (the darker areas in Fig.7).

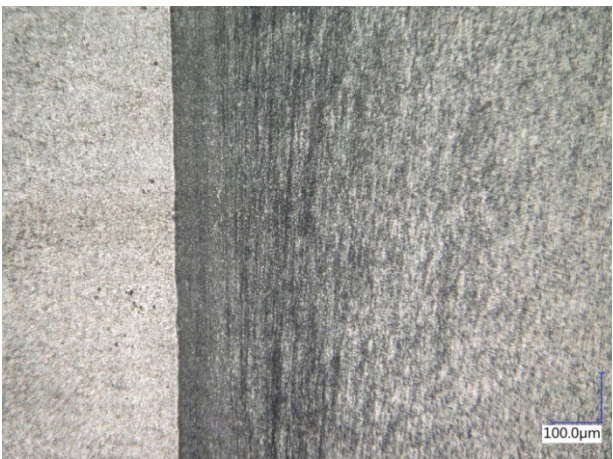
Fig. 7. Thermo-mechanically affected zone (TMAZ) in the 1.4021 steel (on the right from weld)

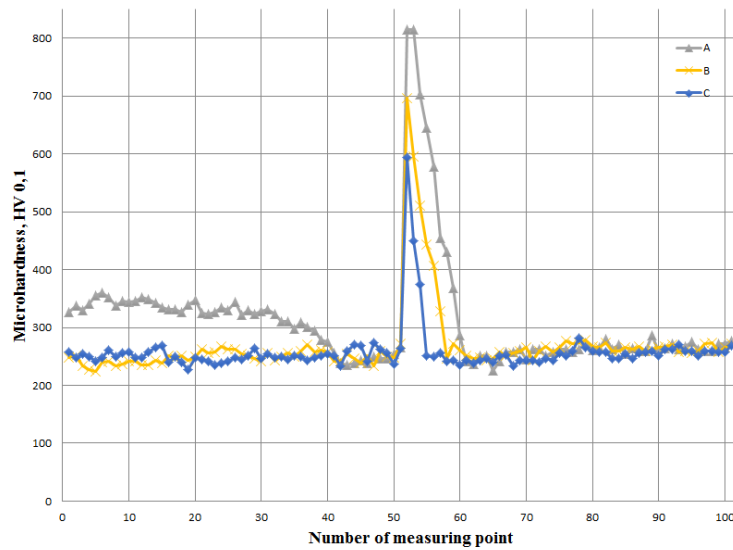
Fig. 9. Microhardness profiles

The hardness of the base materials cores exhibits similar values of about 260 HV₀₁. The hardness increases rapidly near the weld line by the martensitic steel side. Line A presents measurement near the specimen's outer side, and the highest value is 814 HV₀₁. In line C, the highest measurement is 594 HV₀₁, and in line B – 696 HV₀₁. In the TMAZ of reinforcing steel, the hardness slightly increases, but close to the outer area, it decreases to the base material value. The difference in microhardness value between the center and outer region can be attributed to the supplied heat distribution, and therefore differences in microstructure arise [7]. The hardness increase in the area close to the weld is a common situation, and it can be explained by quenched martensite microstructure formation [1, 8]. In special quality applications such as the automotive industry, such a joint would need a post-weld treatment to lower the hardness in the weld. Another possibility is to use a transition layer [2, 9]. The hardness is the end value in the investigated joint, and technology does not demand a post-weld treatment or flash removal.

Microstructure and hardness. The microstructure of base material 1 - B500B steel comprises outer tempered martensite, an inner core of ferrite-pearlite (Fig. 2 on the left), and between a narrow bainitic transition zone. The maximum hardness is achieved near the ribs side (Fig. 9 left side of the A line), decreasing towards the center. The macrostructure presented in Fig.4 reveals a darker area of peripheries by the rebar side. In the core of the bar close to the weld line, grain refinement can be observed, and the grain size increases toward the distance of the weld line (Fig.5). Closer to the ribs side, grains growth appears instead of refinement, and near the weld, several secondary surfaces are part of a partially mixed region (Fig.6). The thermo-mechanically affected zone of the reinforcing steel side was presented in Fig.8.
