# Development and industrial implementation of a biodegradable surgical wire production technology from ZnMg0.004 alloy: *In vitro* assessment of degradation rate and mechanical property changes

**Abstract.** The paper discusses the technology for the production of the new biodegradable surgical wire, developed at AGH, along with the experience of its integration into INTERMECH's production processes. This wire's basic mechanical and corrosion properties are thoroughly examined. The developed technology is based on the use of a combination of hot and cold (in the last passes) drawing of a workpiece obtained by hot extrusion. Hot drawing allows to achieve the necessary ductility of the wire, while the final cold drawing improves the surface quality, which is important in the context of the biological properties of the wire. To assess biodegradation rates, *in vitro* testing was conducted within a natural corrosive environment (using bovine serum from Biowest). Mechanical tensile tests were performed on wires at various stages of corrosion, ranging from 3 to 30 days, in addition to the original wire. These tests were carried out using a Zwick 250 testing machine. The study revealed

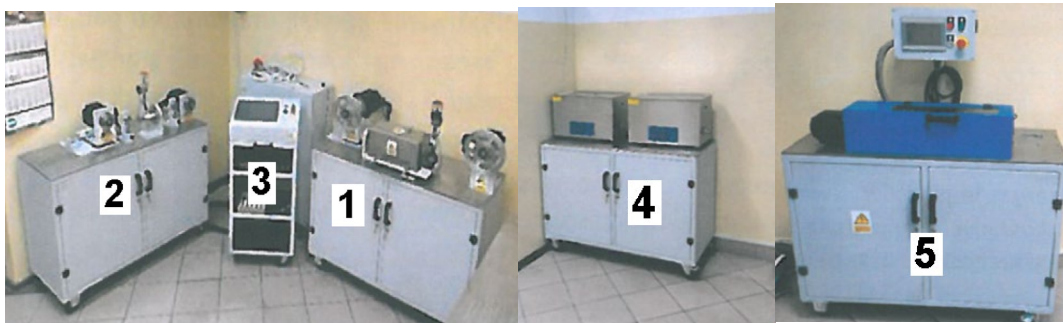
Fig. 1. Industrial technological line (INTERMECH Sp. z o.o.): 1 – the device for hot drawing; 2 – the device for cold drawing; 3 - the control electronic system; 4 – devices for ultrasonic cleaning; 5 - mechanical testing machine of the final wires.

- Hot drawing (Fig 1, position 1): The extruded material is subjected to hot drawing, which commences at a temperature within the deformation zone ranging from 150 to 200°C. This process reduces the wire's diameter to 1.3 mm. The drawing speed is set at 10 mm/s.

- Cold drawing (Fig. 1, position 2): Subsequent drawing continues at room temperature, further reducing the wire's diameter from 1.3 mm to its final size of 0.8-1.0 mm.

- Ultrasonic cleaning (Fig. 1, position 4). At the penultimate stage, the wire undergoes an additional cleaning step, where it is immersed in an ultrasonic bath filled with water and a small quantity of liquid soap. This ensures the removal of any residual impurities.

- Final rinse: The wire is finally rinsed for 15 minutes in a solution of 70% alcohol, further enhancing its cleanliness and suitability for biomedical applications.
- Mechanical testing of the final wires in the manufacturing process can be performed in dedicated equipment (Fig. 1, position 5).

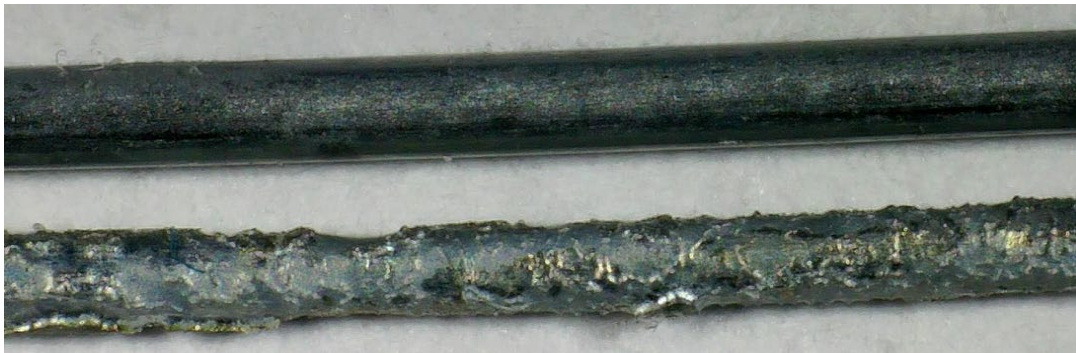
Fig. 3. Wire with an initial diameter of 1 mm before (top image) and after 28 days of corrosion (bottom image).

The main research results are presented in Fig. 4. The change in the maximum force corresponding to wire rupture depending on the corrosion time is shown in Fig. 4,a. It follows from it that the decrease in wire strength over a month of corrosion was 33% and 47% for wire with an initial diameter of 1 and 0.8 mm, respectively. No statistically significant changes in the mechanical properties of the wire material (Young's modulus and tensile strength, Fig. 4,b and 4,c, respectively) were recorded. For these parameters, an increase in the measurement error is observed, which is associated with an increase in the measurement error of the wire diameter after corrosion, which becomes more uneven along the length than for the original wire (Fig. 3).
