Seismic Vulnerability Assessment of a Building Aggregate in the Historical Centre of Florence

[1]Materials and Structures Division, Department of Architecture, University of Florence, Piazza Brunelleschi 6, 50121 Florence, Italy

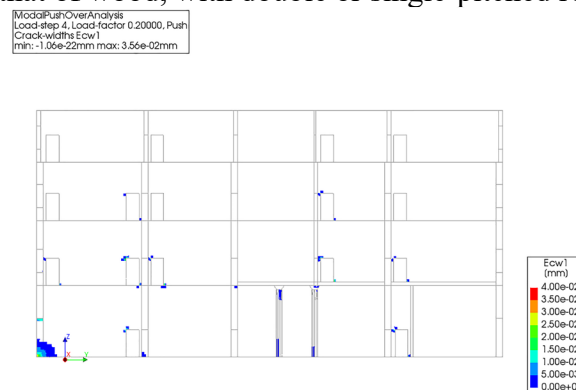
Figure 3. First configuration: the presence of the court is modelled thanks to the insertion of stone columns on the ground floor.

In the configuration with columns, at the same load step, the damage is more extensive, in particular, damage is also found at higher levels than in the first (Fig. 3; Fig. 4).

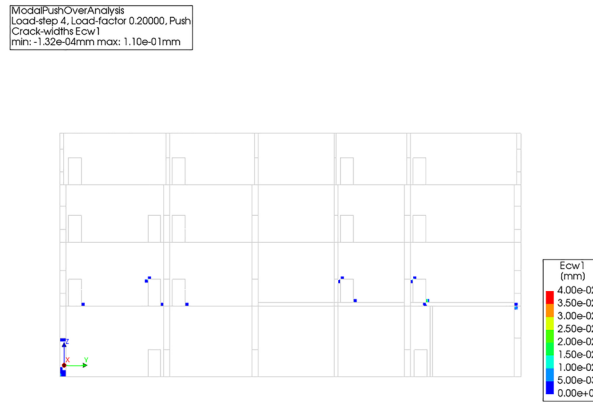
Figure 4. Second configuration: the presence of the court is modelled with walls also in the ground floor, in continuity with the walls in the higher levels.

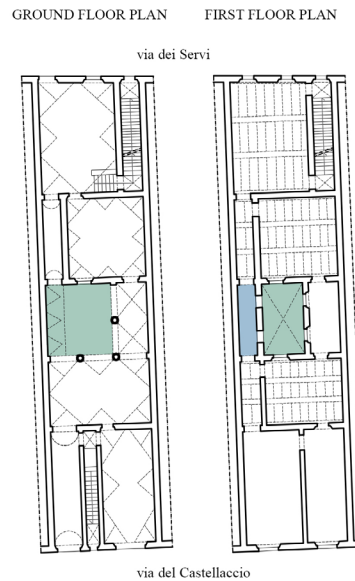
Figure 5. Reconstruction of the original configuration of the units: Ground floor (left) and First floor (right). Identification of the internal court (green) and of the additional cantilevered corridor on the first floor over the same internal court (blue).

To this context, we must add the constructional weaknesses stemming from the evolution and modifications carried out over the years, beginning in the 19th Century. These include the construction of an additional cantilevered corridor on the first floor over the same *internal court* (Fig. 5).

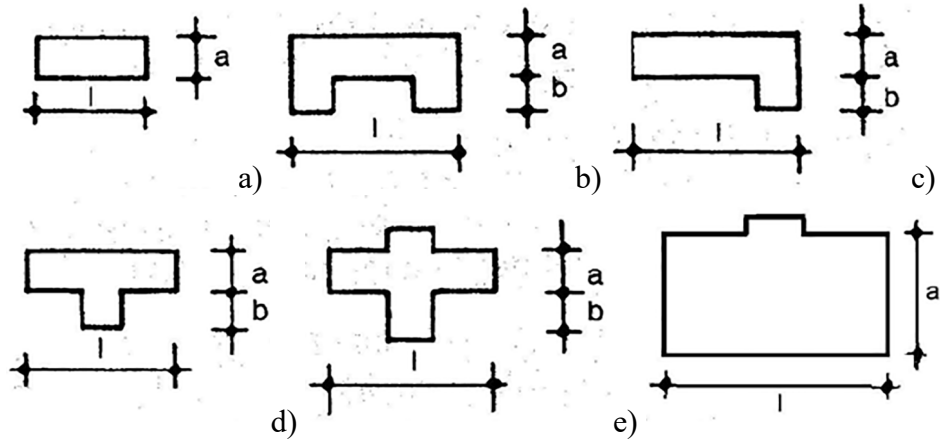
Figure 6. Plan irregularity. Schemes for calculating the plan irregularity β_2.

Regarding the plan irregularity, the ratio of the area of the *internal court* A_0 to the total area A_t is equal to 6%. For the calculation of the irregularity β_2 of the floor, which features an opening at the *internal court*, an approximate reference was made to the diagram in the manual (Fig. 6b), resulting in 9.8%, which is less than 10%, considered as the minimum value from the manual to indicate irregularity.

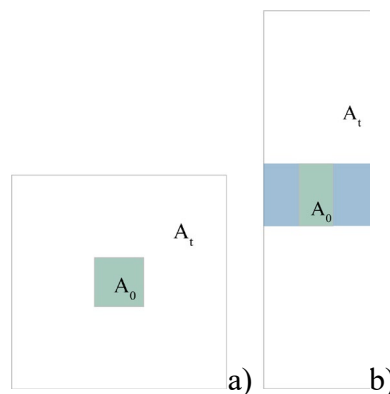
Figure 7. Plan irregularity. Distribution schemes to evaluate the transverse measure of the court in relation to the transverse measure of the plan. $A_0 = 20\ m^2$; $A_t = 314.64\ m^2$; $A_0/A_t = 6\%$. Identification of the cantilevered floor (blue).

An assessment of the irregularity due to the presence of the *internal court* with respect to the floor slab could be made, not so much in relation to the A_0/A_t ratio, but to the ratio between the widths of the courtyard and the entire building. Taking into account the two models (Fig. 7), with $A_0 = 20$ m^2; $A_t = 314.64$ m^2, with an equal A_0/A_t ratio of 6%, considering the horizontal direction, model 7a) represents the better condition, in which the ratio between the width measurements is 0.2 (1:5), compared to case 7b) in which the width ratio is 0.3 (1:3), which becomes 1 (1:1) considering the further widening of the courtyard, considering that the slabs resting on beams do not offer stiffness comparable to the rest of the slabs, as in the case study.
